CREATING READINESS FOR CHANGE IN LARGE INFRASTRUCTURE PROJECTS BASED ON EXPERIENCE FEEDBACK FROM ACCIDENT INVESTIGATIONS

Urban Kjellén, Statkraft and NTNU

HFC Meeting, Trondheim, October 15, 2015

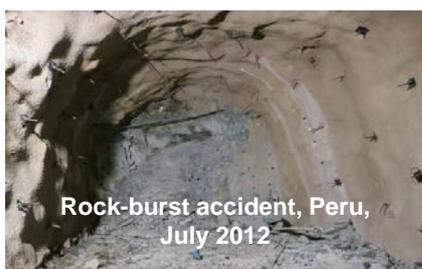
Rock-burst accident, Peru, July 2012

- Risk with (potentially) high consequence not included in risk assessment.
- Technical competence is required to identify the risks.

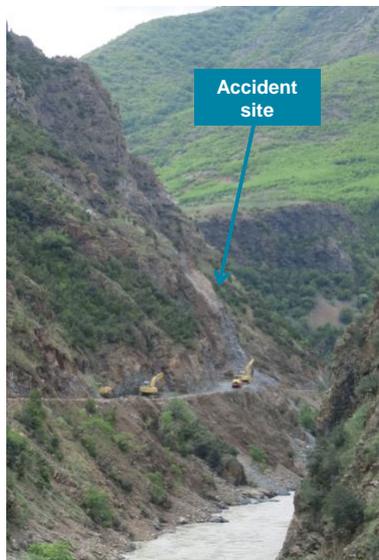
Fatal accident in Albania during road work in April 2014

- ▶ A team of three persons were scaling for loose stones and were about to finish the work
- ▶ A section of rock (1000 m³) started to slide when the crew was located in the danger zone of the rock slide
- ▶ Two scalers were dragged with the rock-slide to the river bed; the supervisor was still hanging in his rope after the slide

Establish a new standard in the planning and execution of scaling and rock support work

- ▶ Overall strategy for moving forward on the road
 - Controlled progress section by section
 - Permit-to-work procedure to ensure compliance
 - Monitoring of precipitation and stop of work in heavy rain
 - Geologist present for detailed planning and supervision of work
- ▶ Requirements to crew member qualifications
- ▶ Step-by-step procedure to ensure controlled execution of work

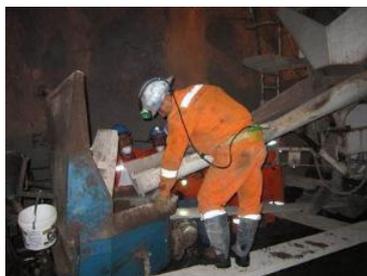
Electrocution accident in tunnel in 2012

- ▶ A tunnel worker was involved in removing stones and clods coming with the cement from a mixer truck while it was transferred to an Alpha 20 shotcrete robot
- ▶ Electric current went from the Alpha robot to the worker's left hand, torso and right hand and to the chute and mixer and finally to ground, see photo
- ▶ The immediate cause of the accident was an earth fault in a 240V halogen lamp mounted on the alpha robot by Contractor to improve illumination at the tunnel face
