Galvanic corrosion in steel-aluminium connections

Ole Øystein Knudsen

Galvanic corrosion test at Helgoland

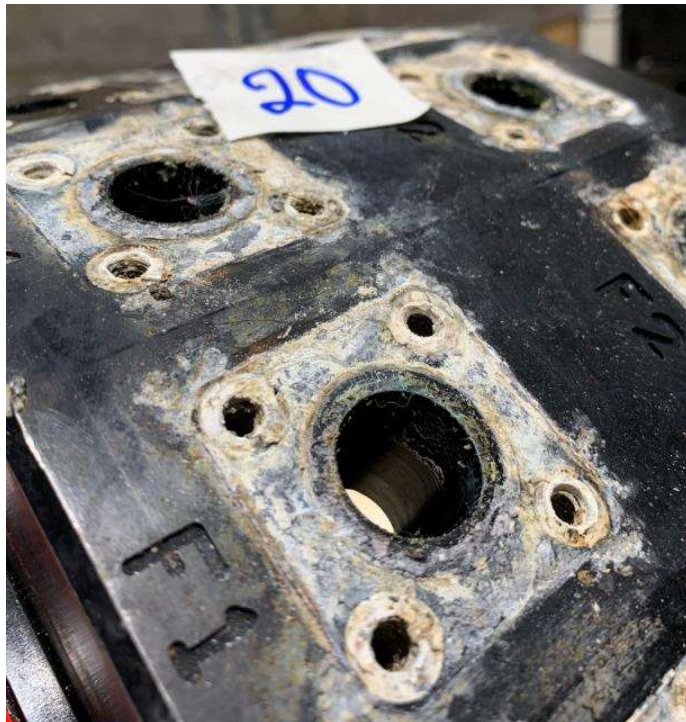
Galvanic corrosion in submerged conditions

- Aluminium parts on subsea ROV
- Stainless steel parts mounted on anodized aluminium (thick film anodized, 50 μm)
- Corrosion in the crevices
- No cathodic protection?
- CP probably not able to penetrate the crevice due to high resistance

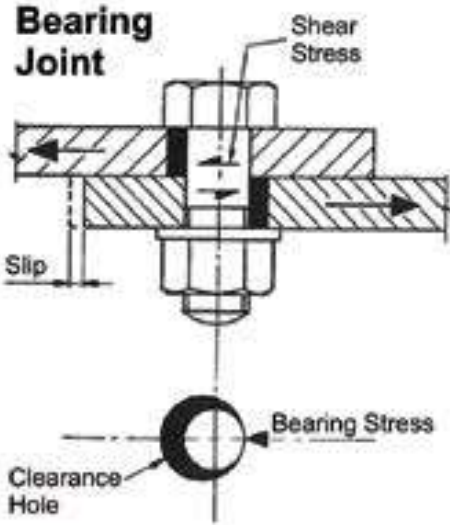
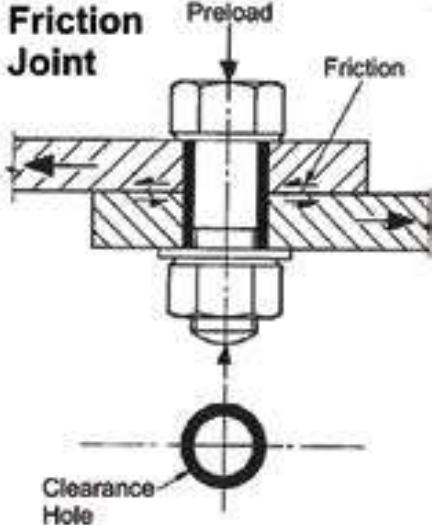
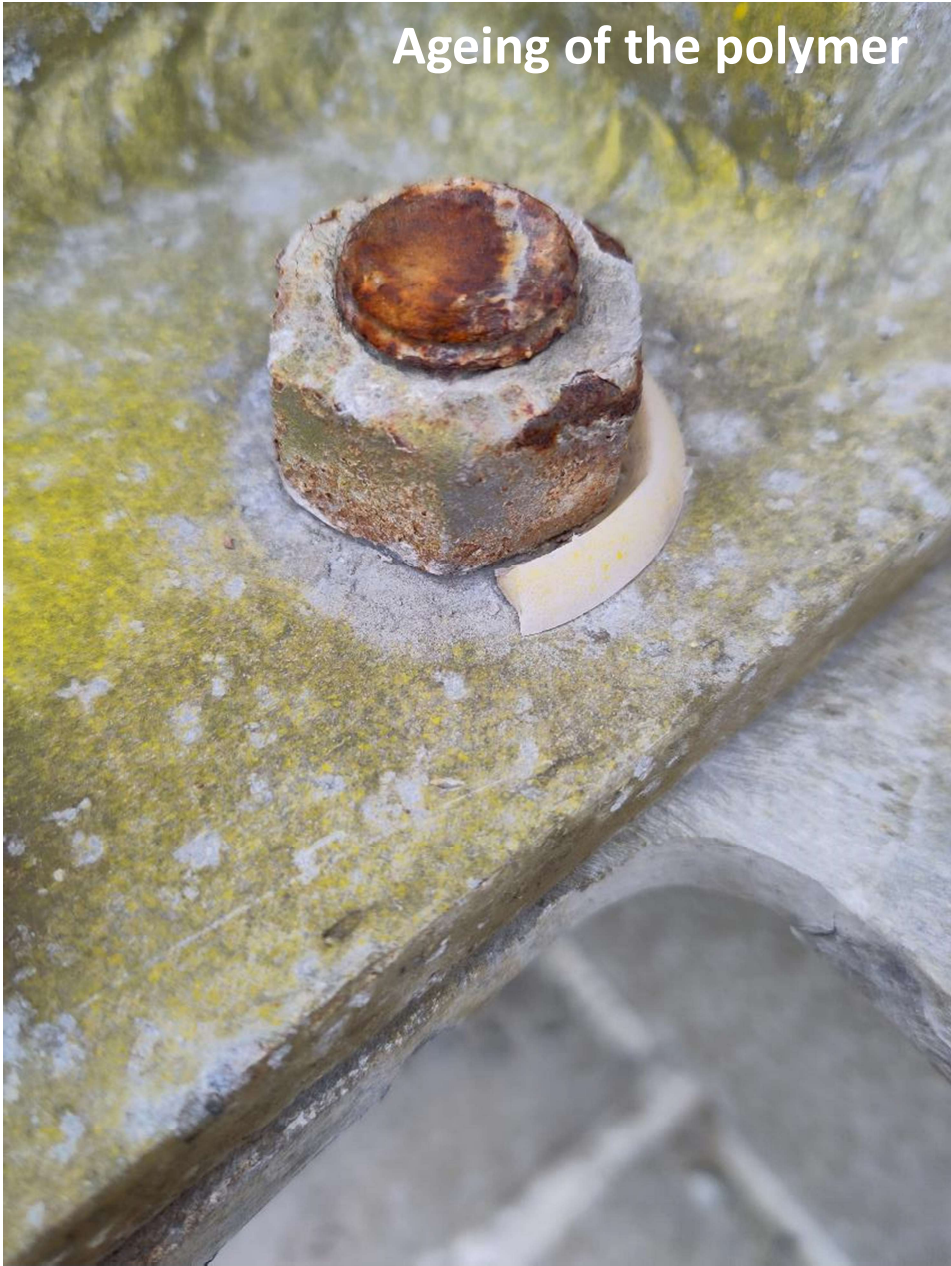
Electrical insulation has sometimes failed

Failure due to mechanical loading of the polymer

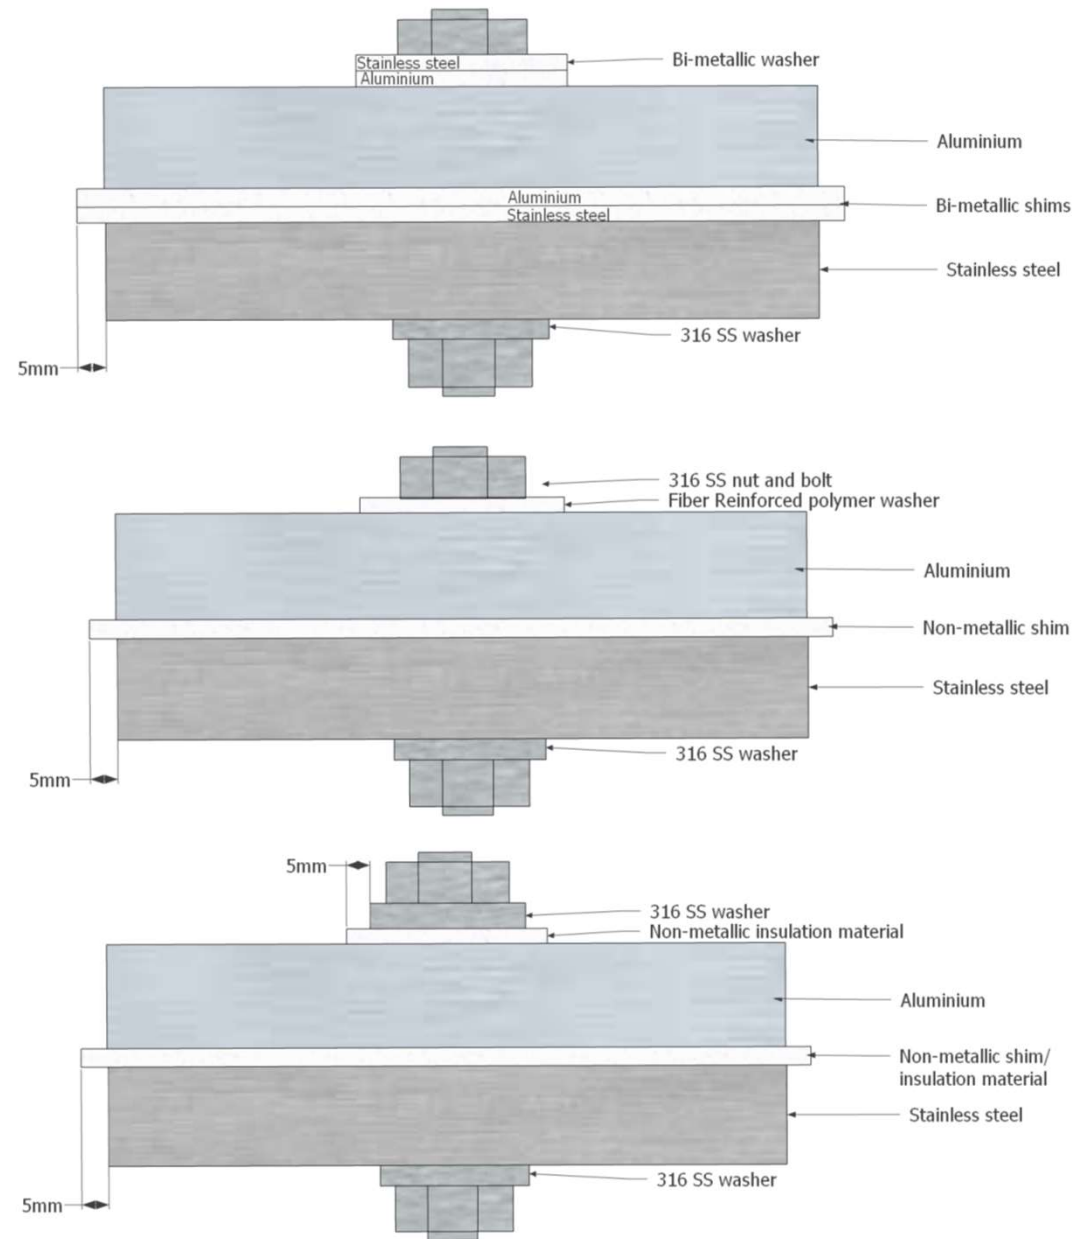
NORSOK M-001:2014 Annex A1

- Nonmetallic shim or bimetallic shim
- Nonmetallic, FRP or bimetallic washer
- Shims are to extend 5 mm beyond the aluminium

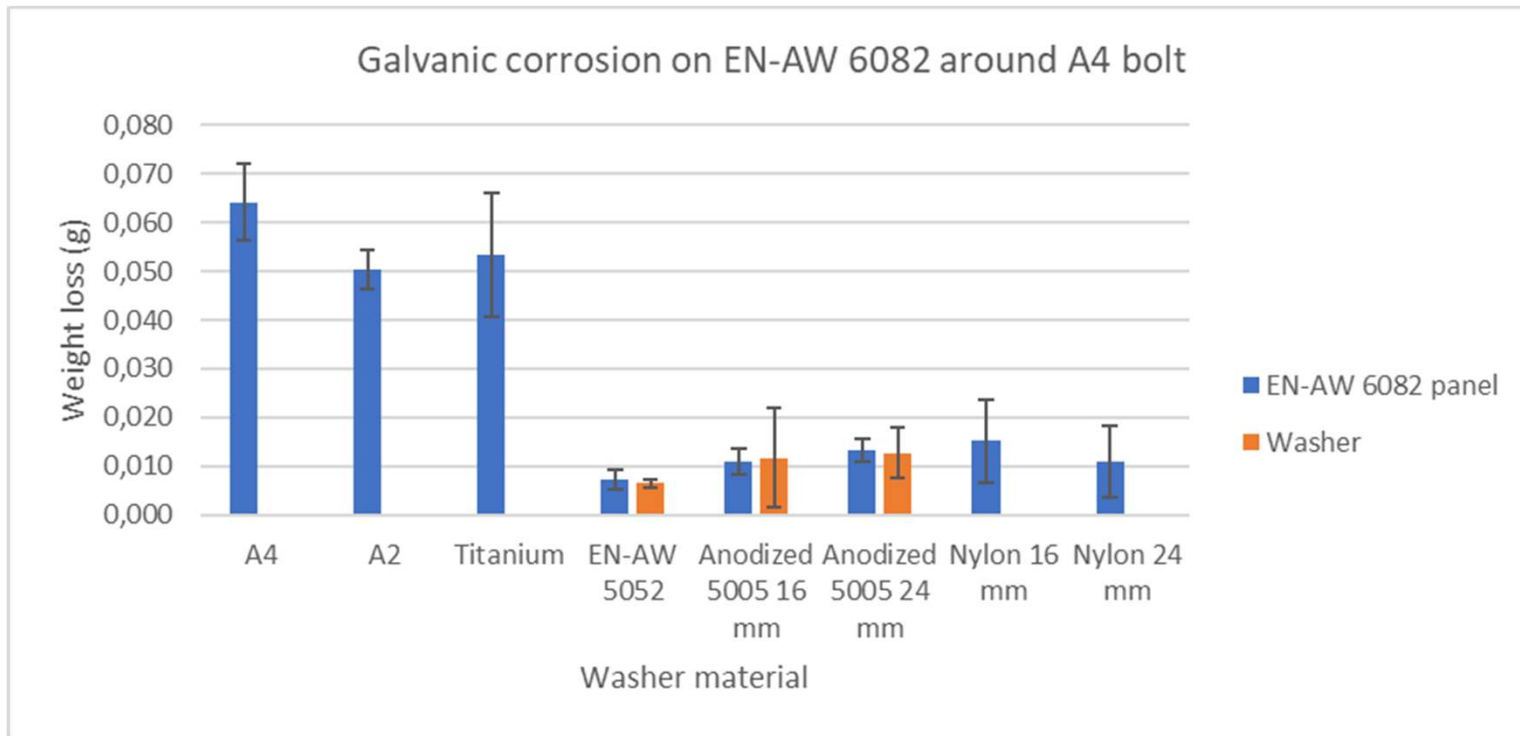
Weight loss on 6082 sample and washers

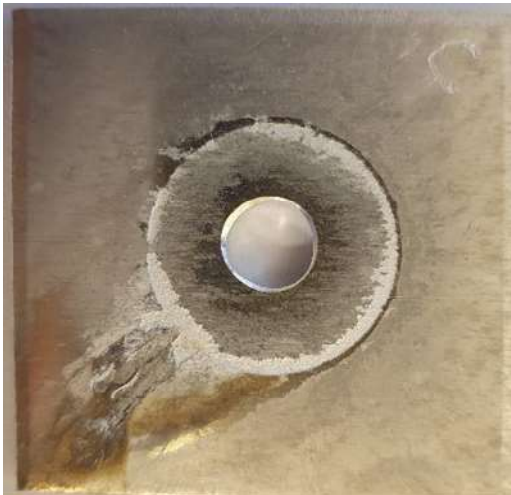
5083, 24 mm anodized washer

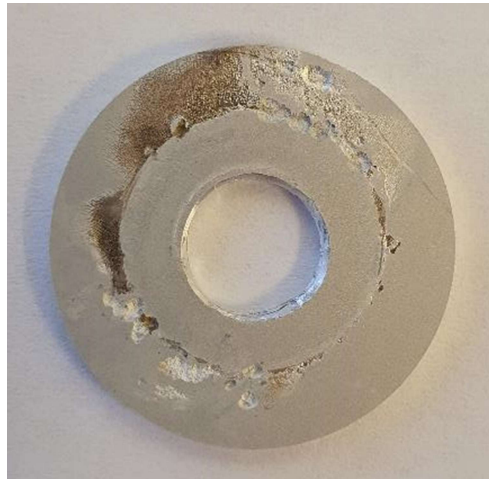
24 mm anodized washer

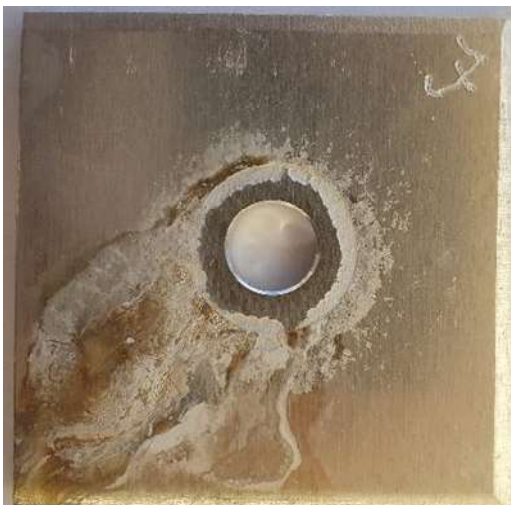
5083, 16 mm anodized washer

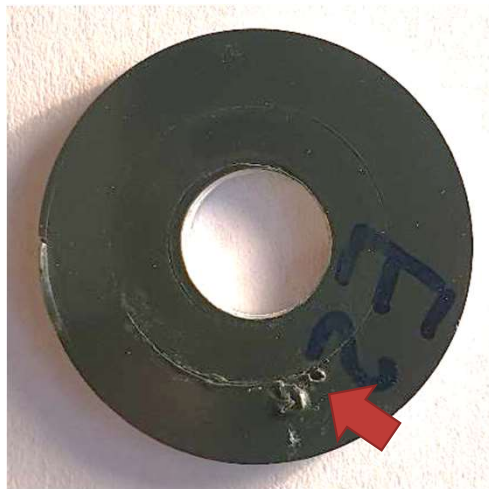
24 mm coated washer

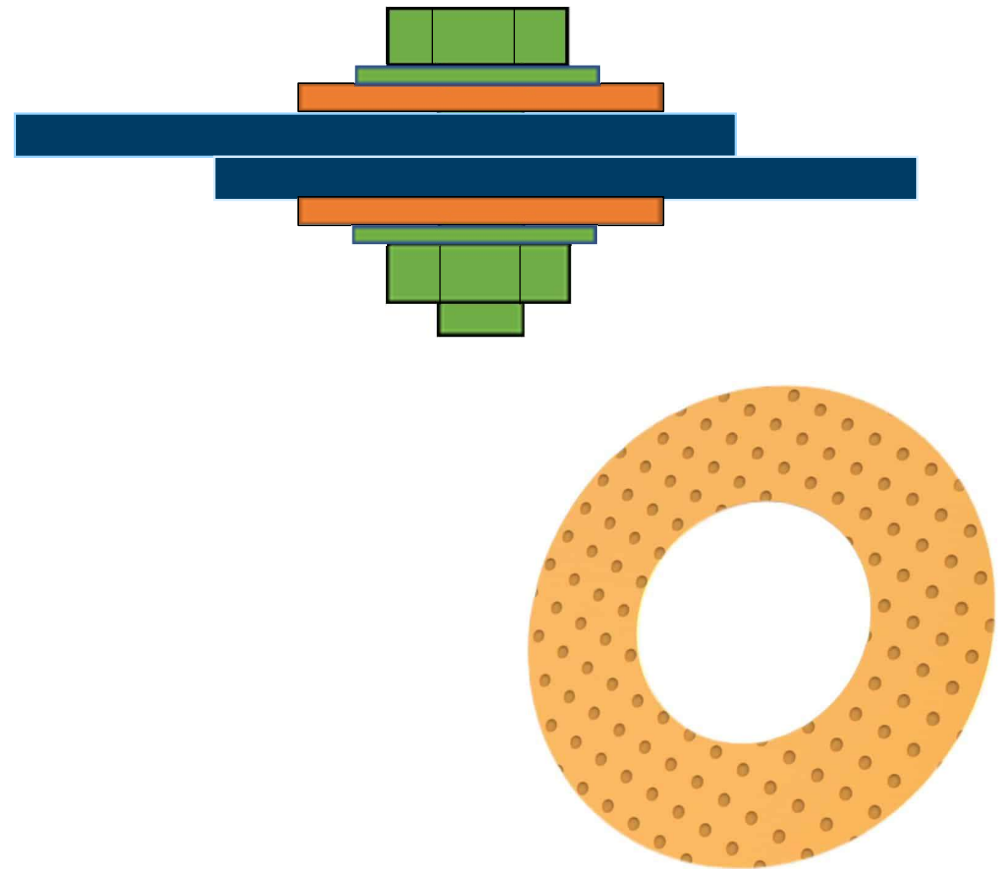
- New revision of NORSOK M-001 to be issued soon
- High strength composite washers
 - Prevent galvanic corrosion
 - Have compression strength comparable to aluminium
- The washer should extend beyond the steel to increase electrolytic resistance between aluminium and steel
- An additional stainless washer under the bolt will reduce risk for crushing the composite
- Sleeve or sealant inside the bolt hole
