LVDT-METHOD RELIABILITY SHALLOW AND DEEP CASES

STRESS MEASUREMENT COMPANY OY
MATTI.HAKALA@SMCOY.FI

LVDT-CELL METHOD

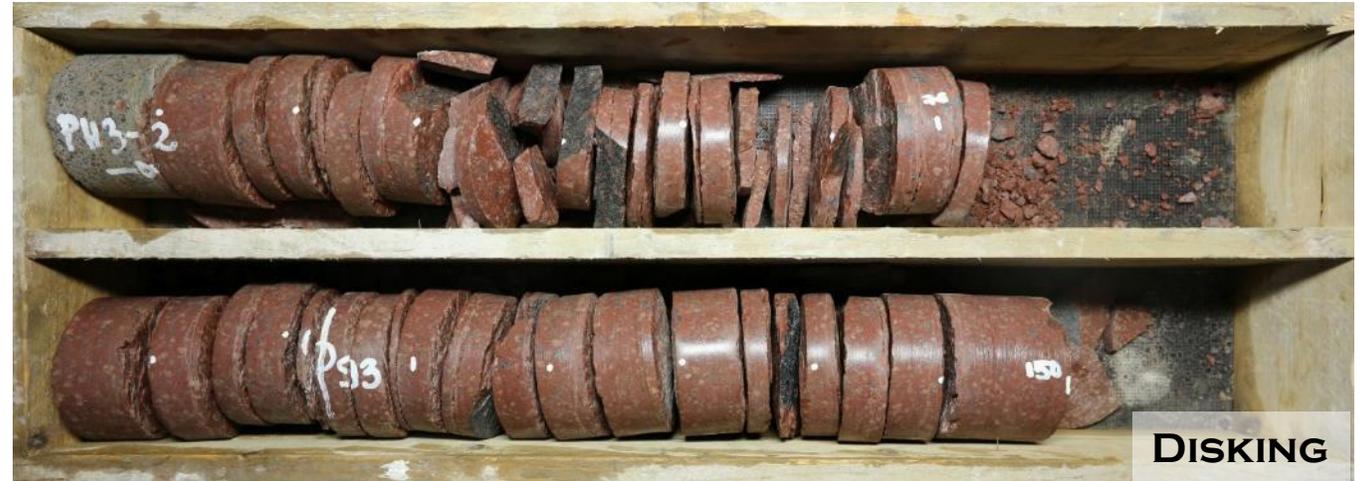
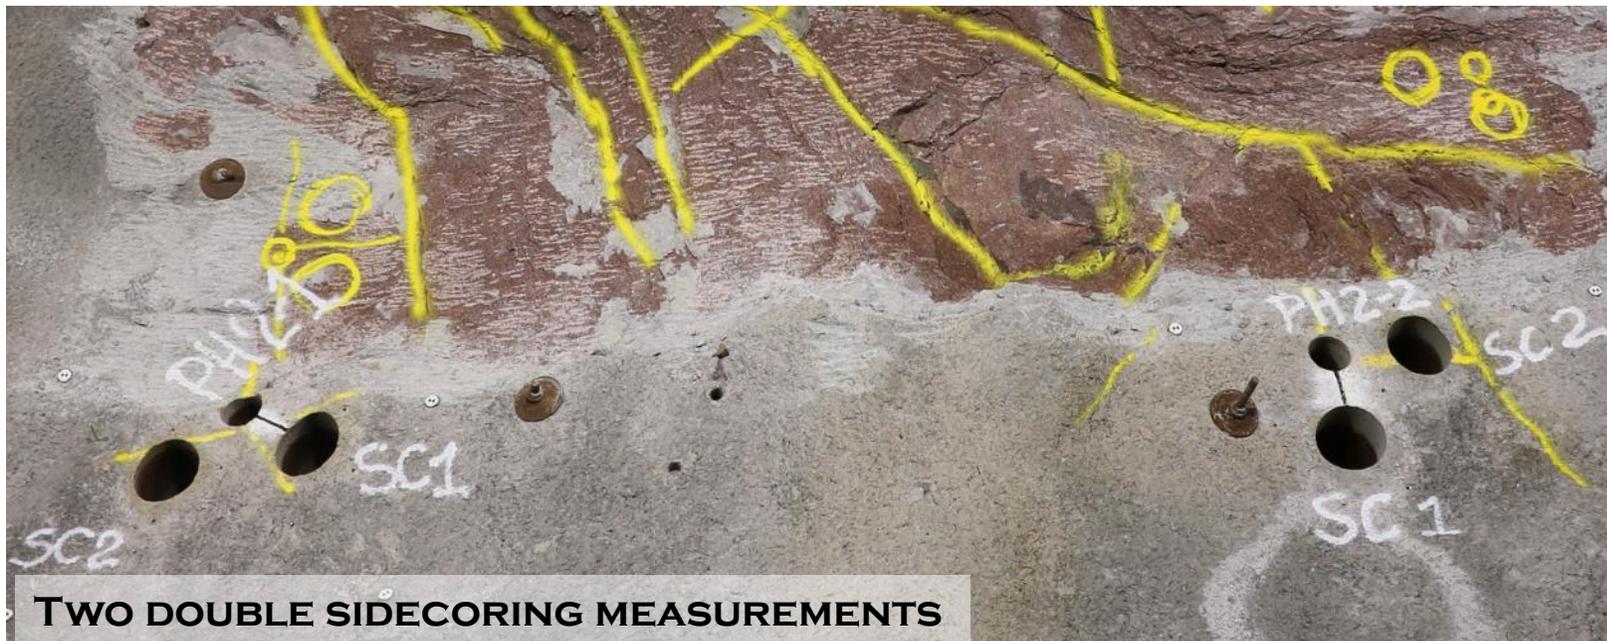
IN HIGH STRESS

- **OVERCORING DOESN'T WORK WHEN DISKING TAKES PLACE**
- **APPLIED INVERSE SOLUTION ENABLES USE OF SIDECORING**
→ PARTIAL STRESS RELIEF
- **SIDECORING WORKS, AS FAR AS PILOT HOLE REMAIN STABLE**

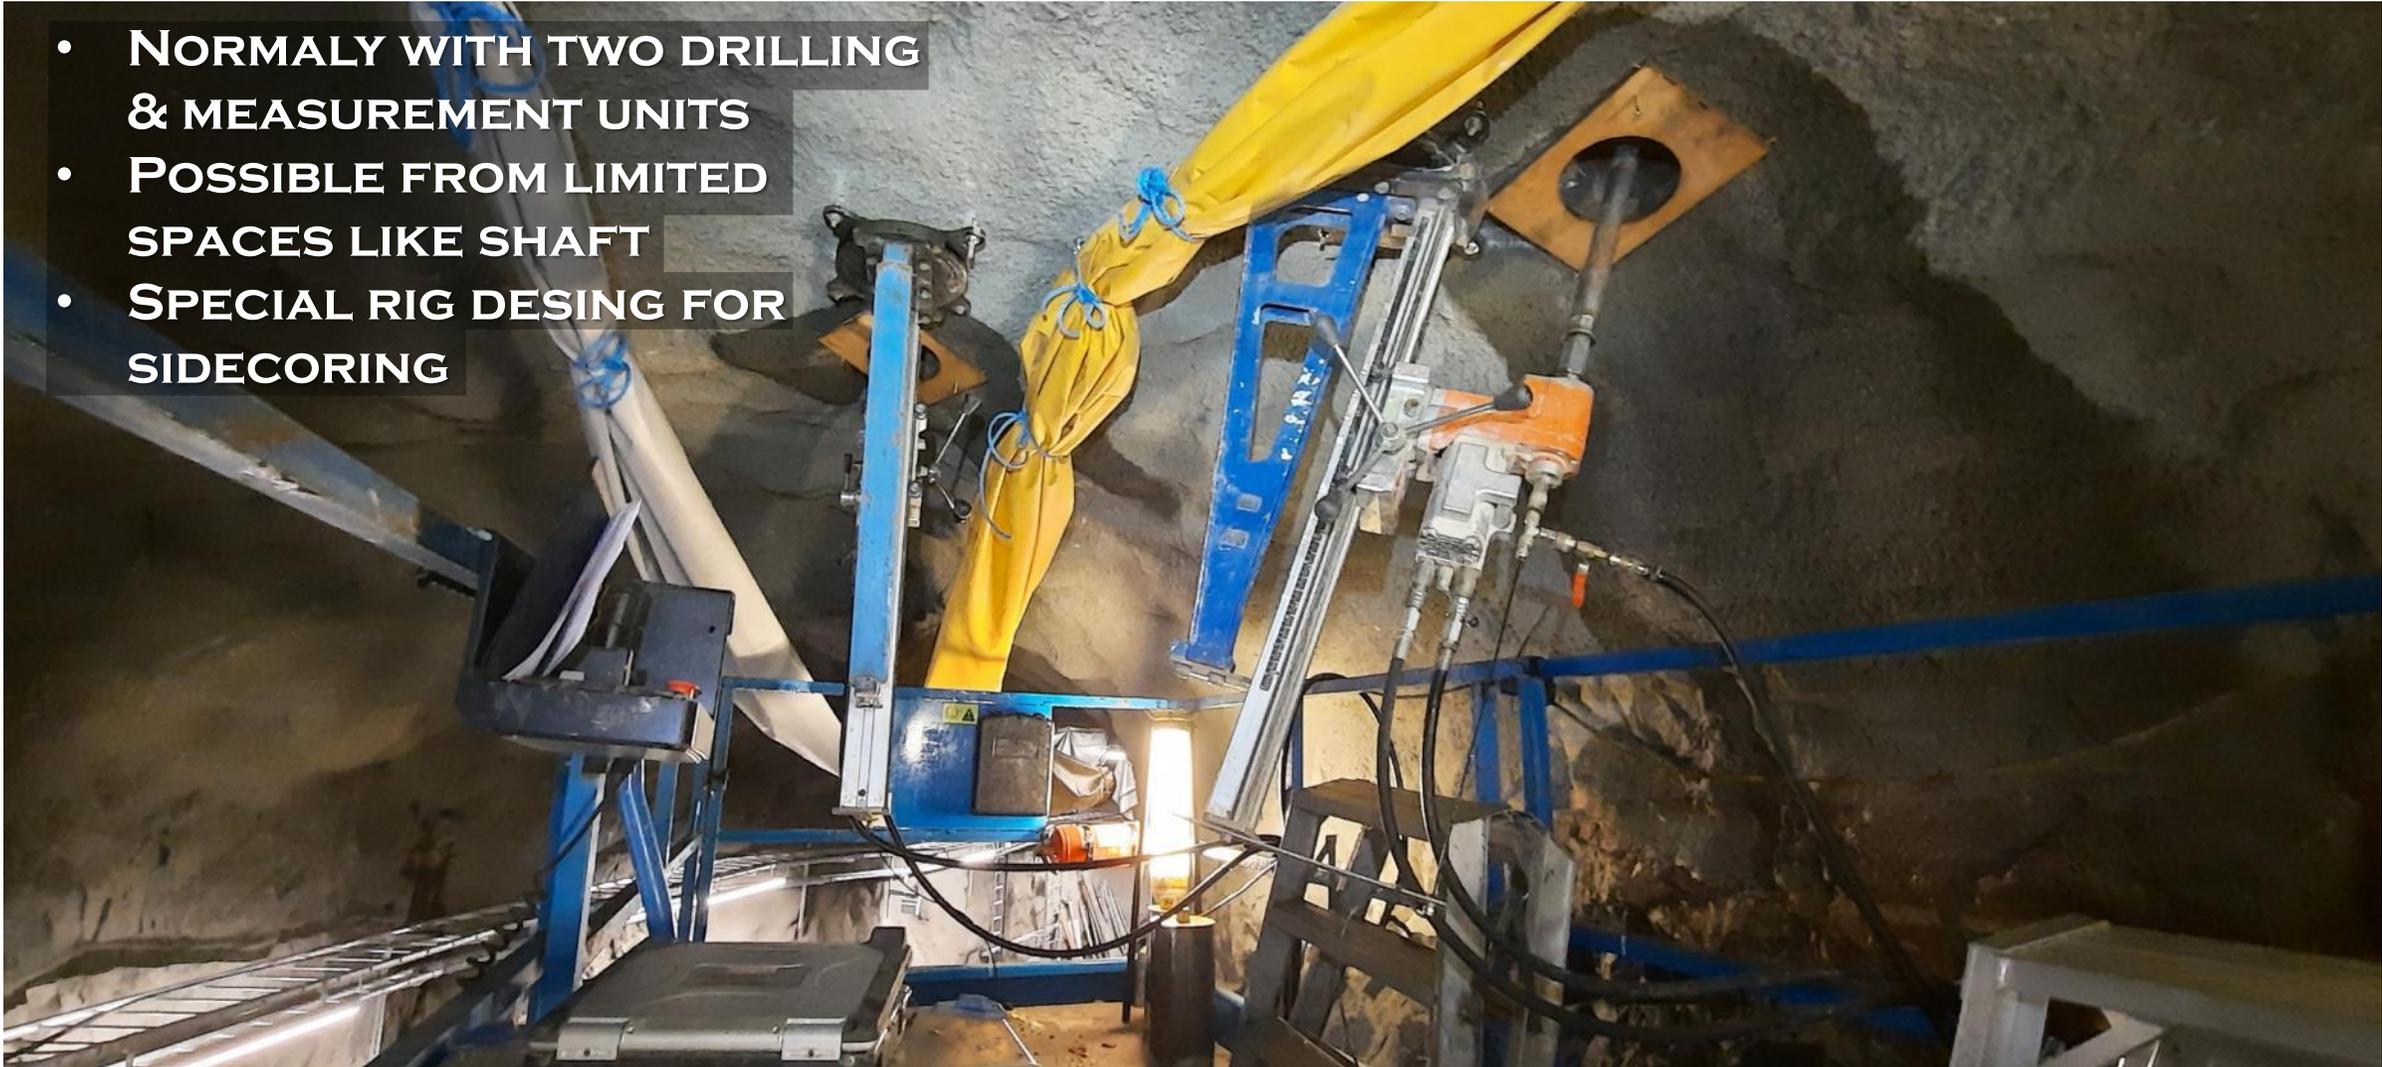
COMPACT DRILL RIG

- **NORMALY WITH TWO DRILLING & MEASUREMENT UNITS**
- **POSSIBLE FROM LIMITED SPACES LIKE SHAFT**
- **SPECIAL RIG DESING FOR SIDECORING**

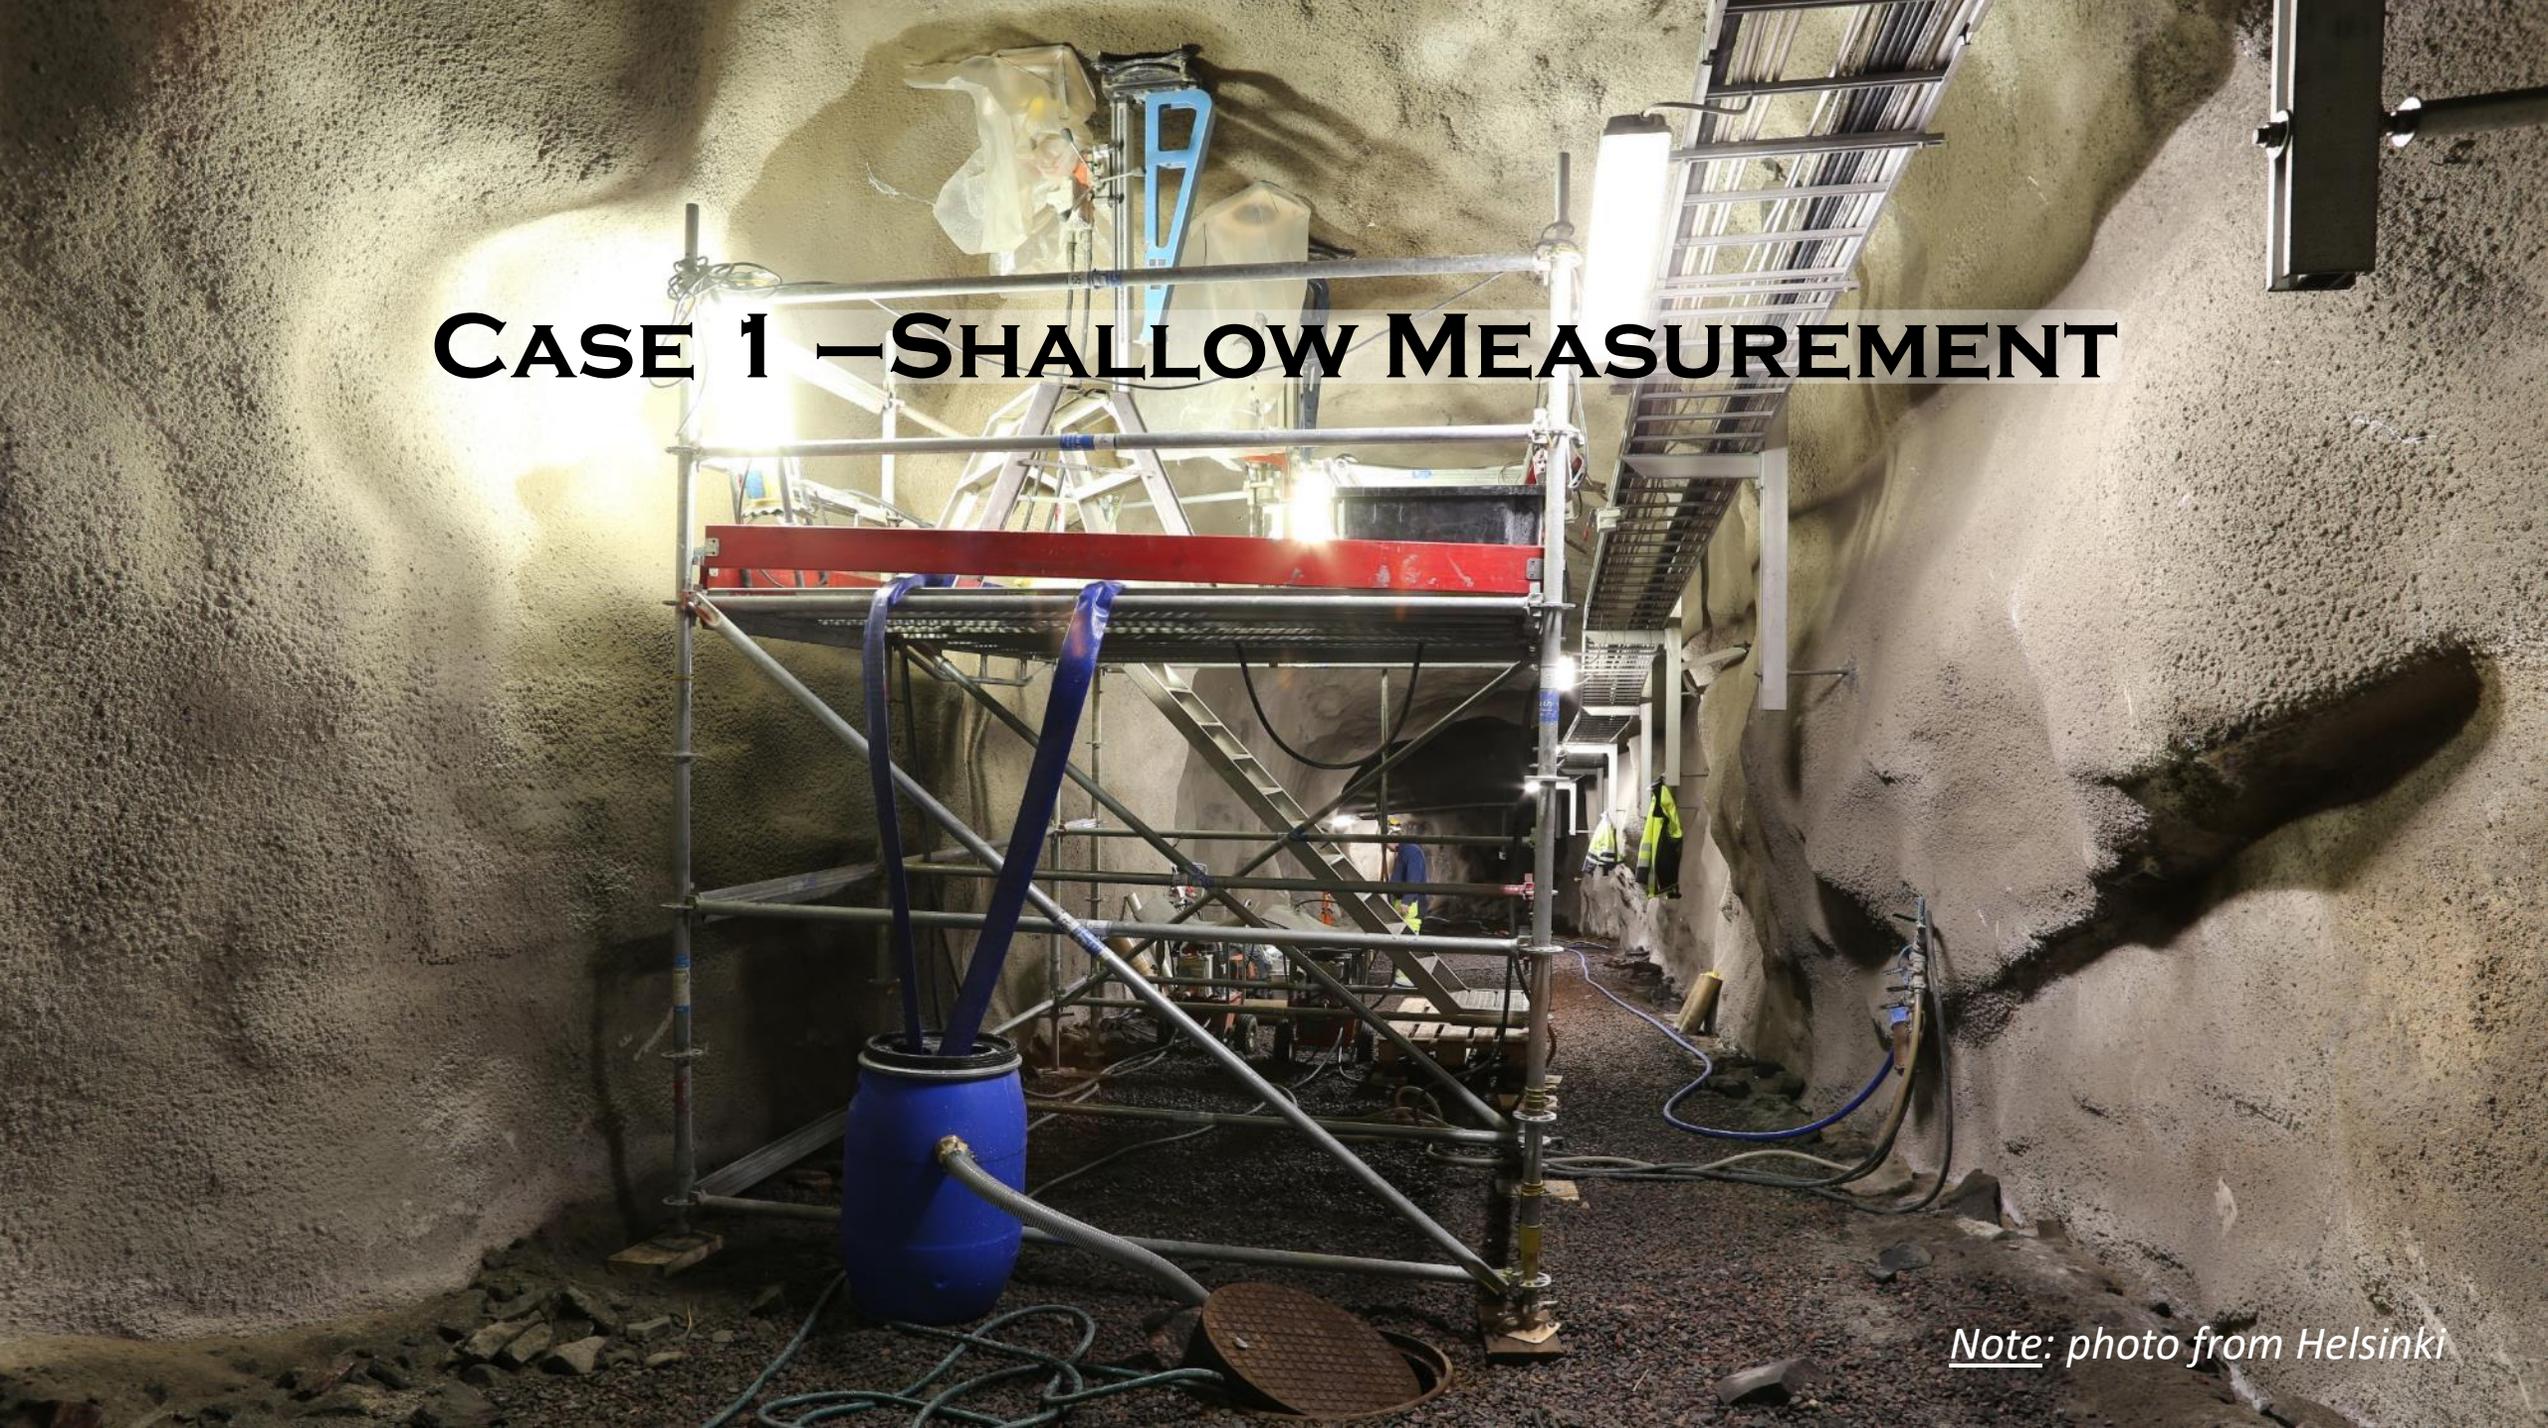
CASE 1 – SHALLOW MEASUREMENT

Note: photo from Helsinki

- 3D IN SITU STRESS INTERPRETATIONS AT THREE LOCATIONS ABOUT 30 M DEPTH
- MAXIMUM DISTANCES BETWEEN THE MEASUREMENT LOCATIONS WAS LESS THAN ONE HUNDRET METERS
- DOMIANT ROCK TYPE IS GNEISS WITH GRANITIC VEINS
- ROCK IS MODERATELY JOINTED
- DEPTH OF EXVATION BLAST DAMAGE WAS LESS THAN 20 CM

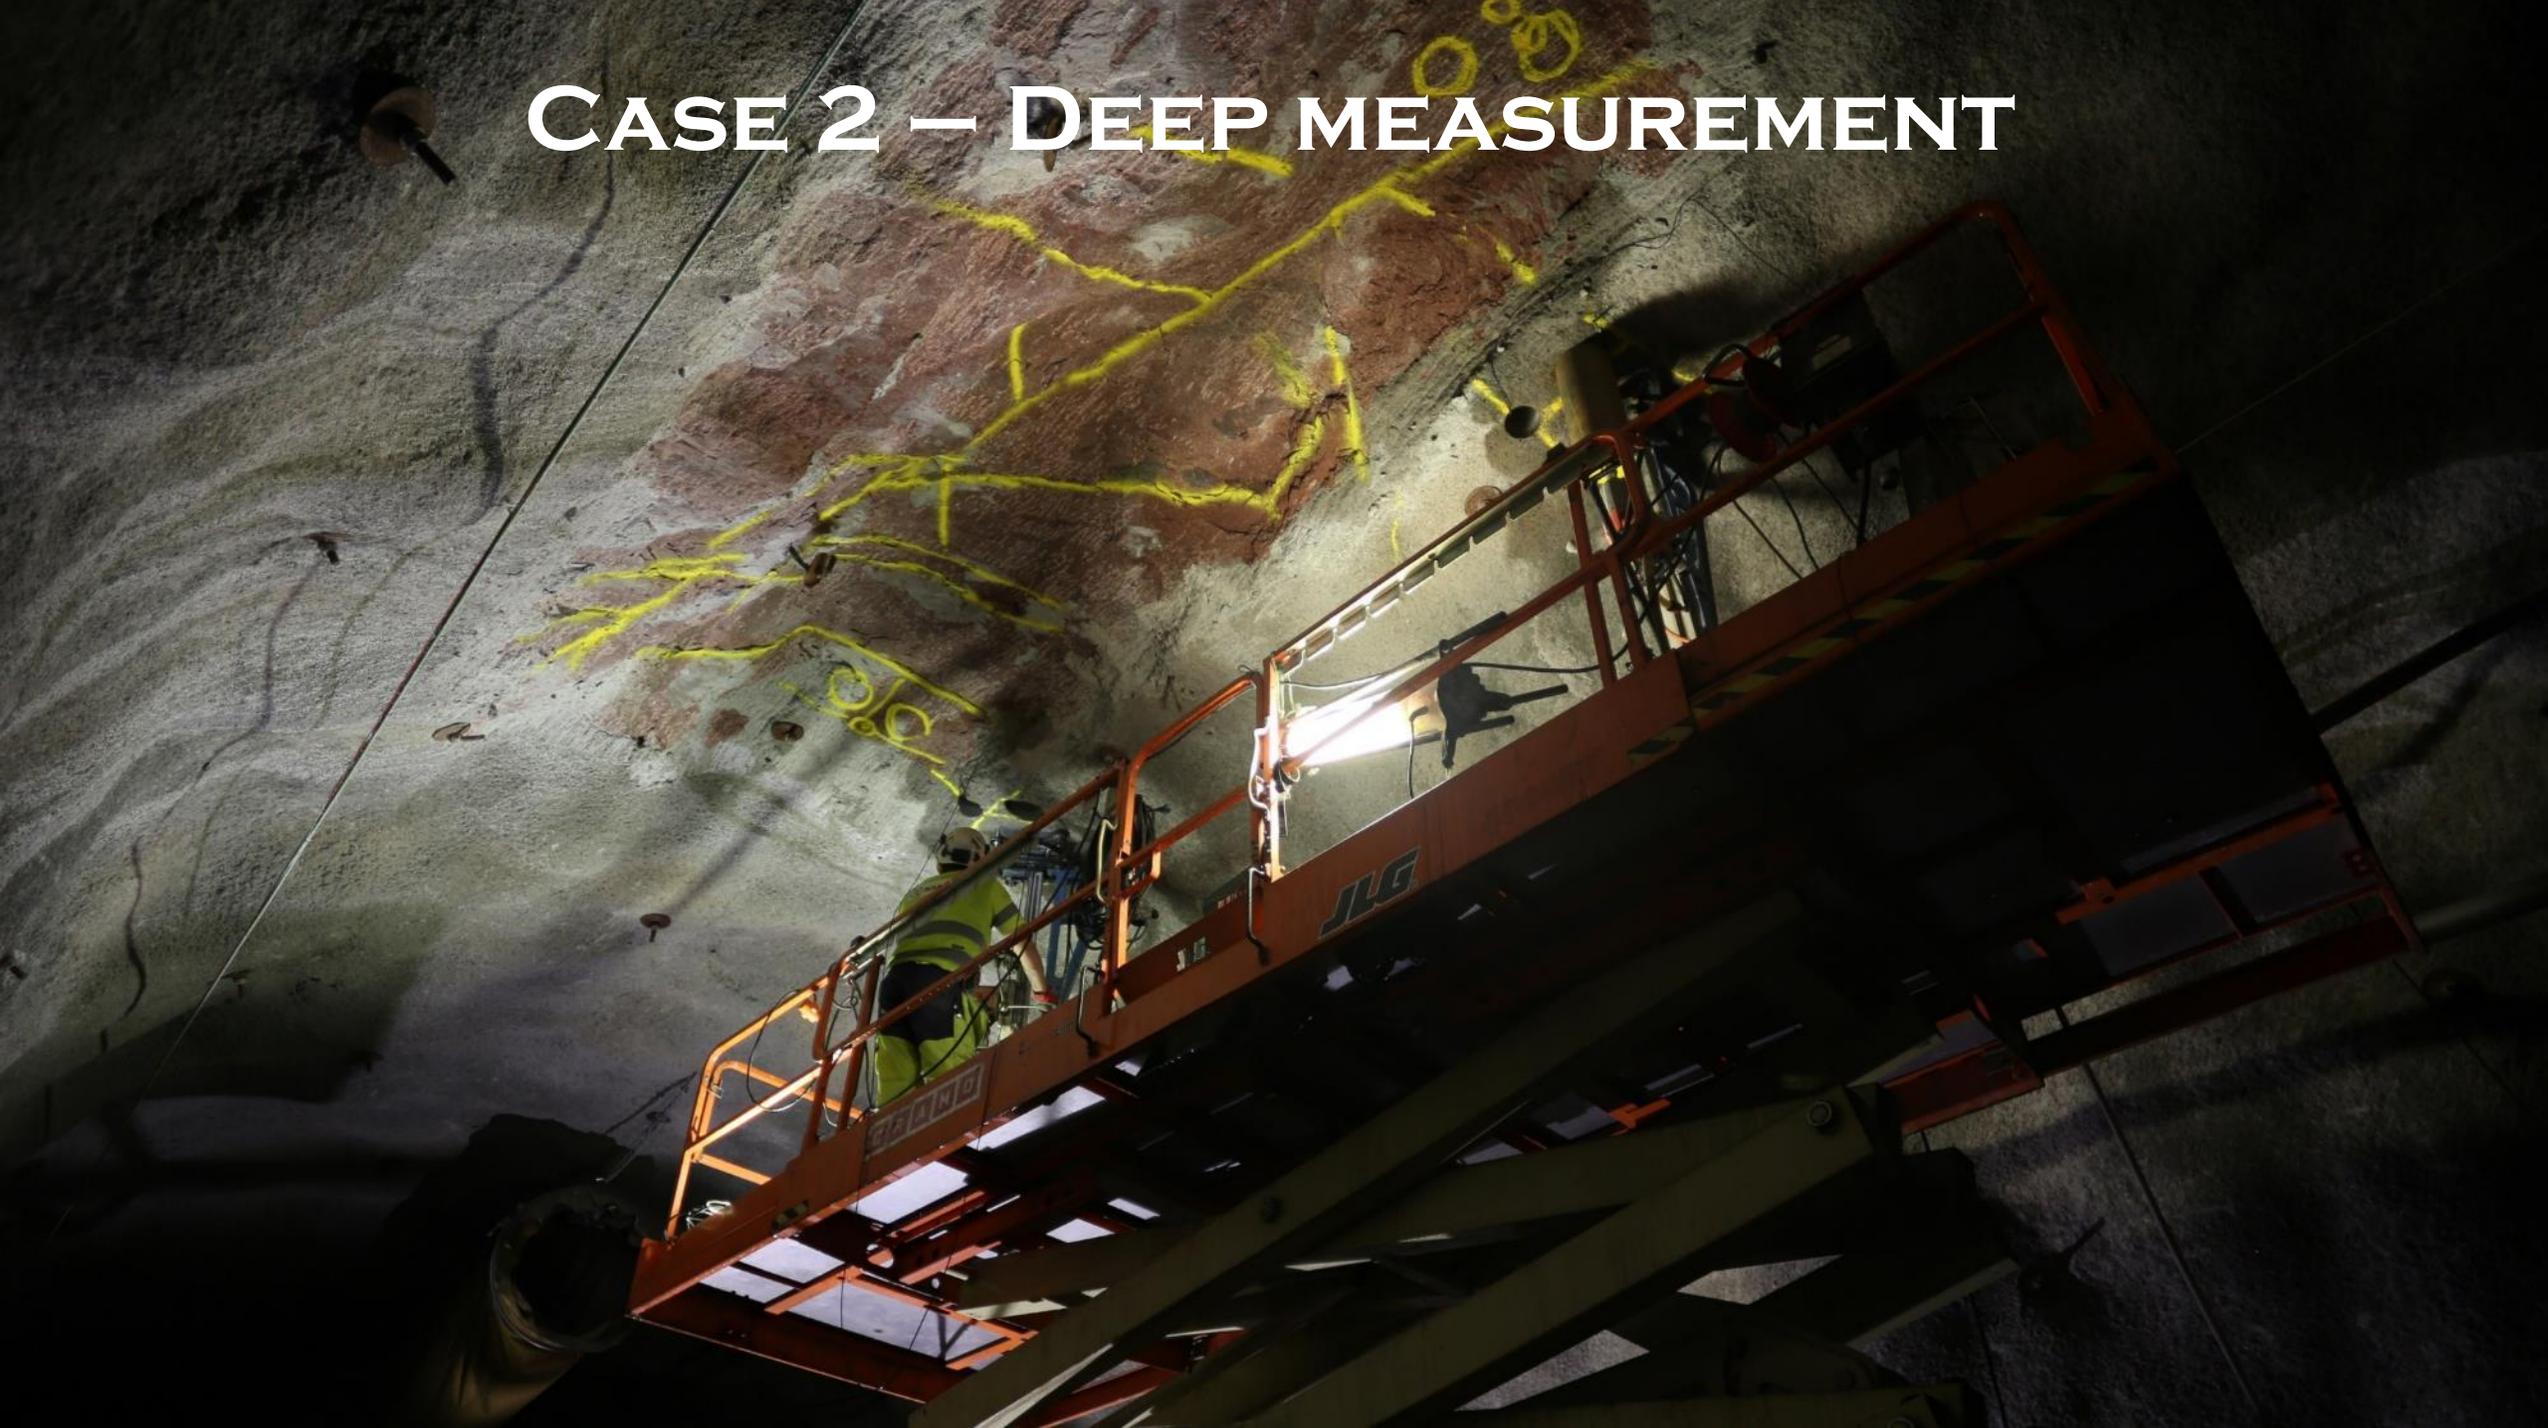
CASE 2 – DEEP MEASUREMENT

MEASUREMENTS FOR HORIZONTAL IN SITU STRESSES AT THREE LOACTIONS IN LKAB KIRUNA MINE AT 1375 LEVEL

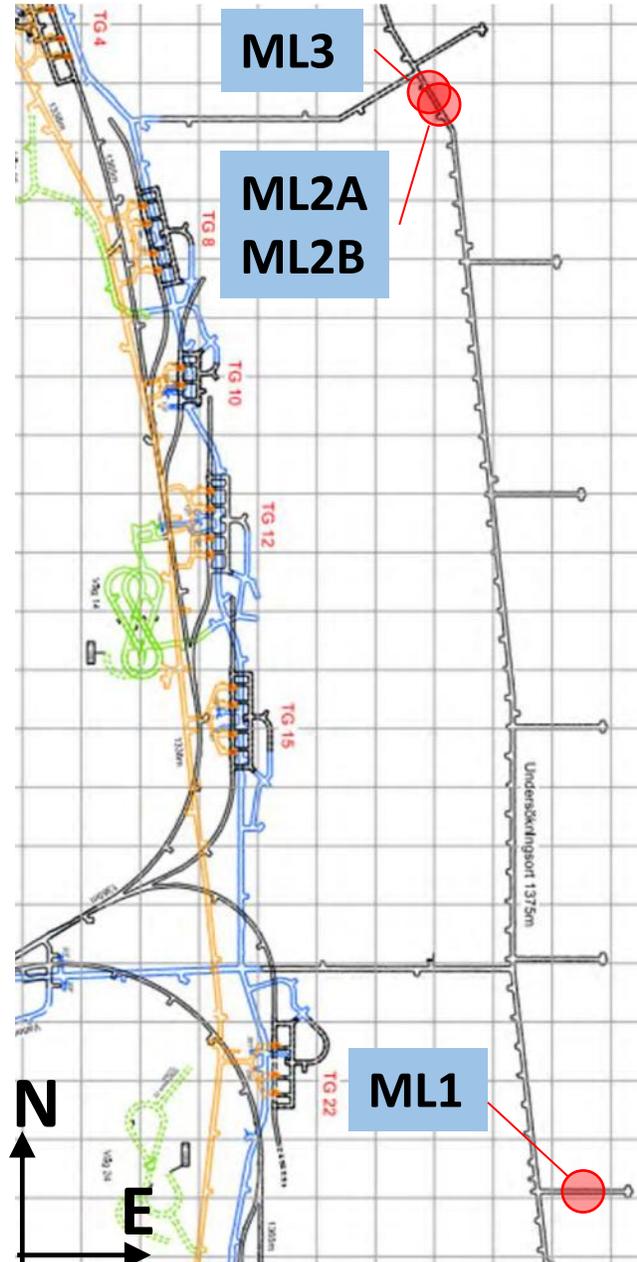
ML1: Densely fractured
- *very hard to find installation location*

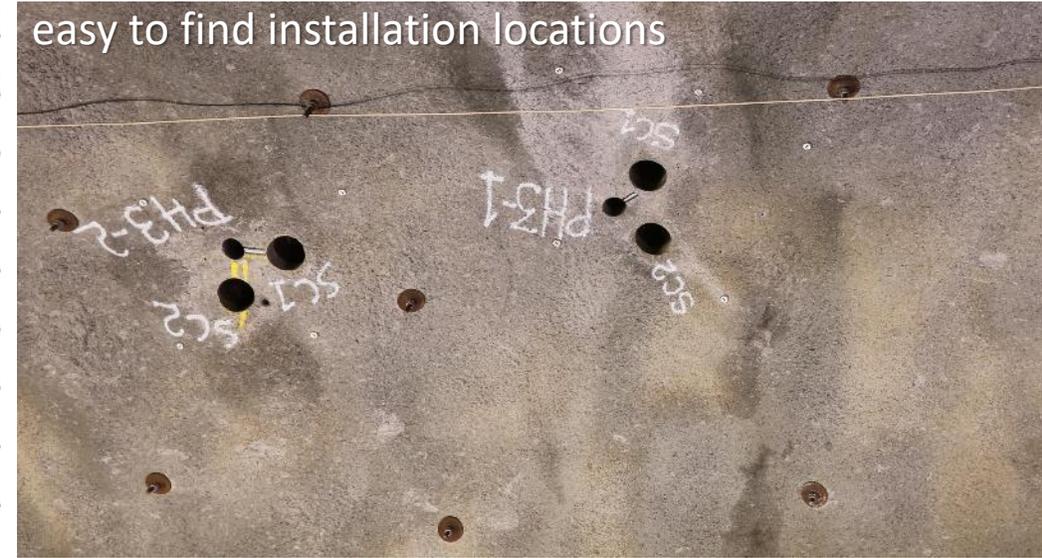
ML3: thin sprayed concrete,
easy to find installation locations

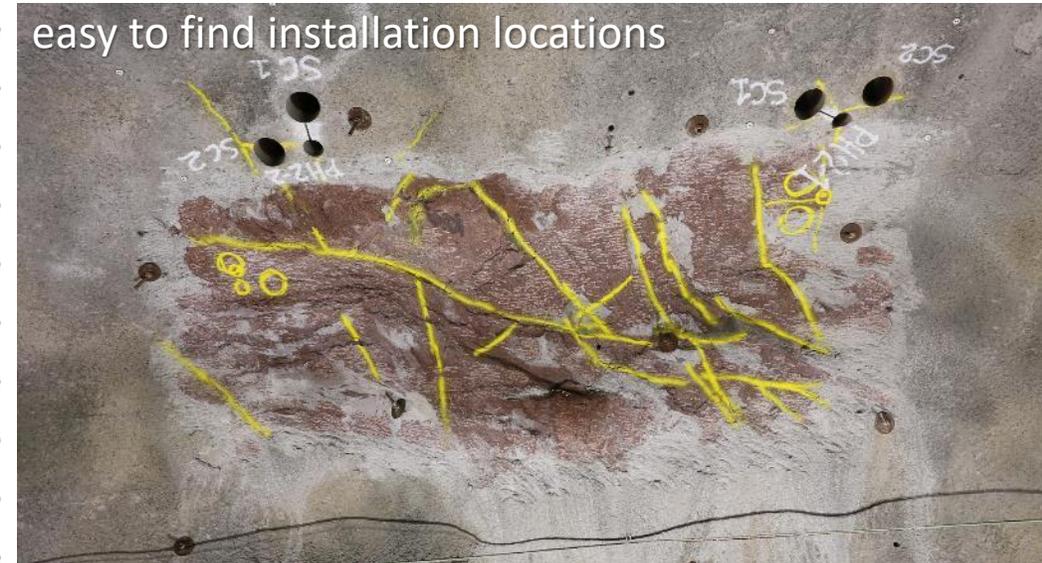
ML2: Sparse to moderate fracture spacing,
easy to find installation locations
