# Influence of pre-treatments on the corrosion of bare and painted AA6082 aluminium alloys for marine applications

# Experimental: Pretreatments & Paint

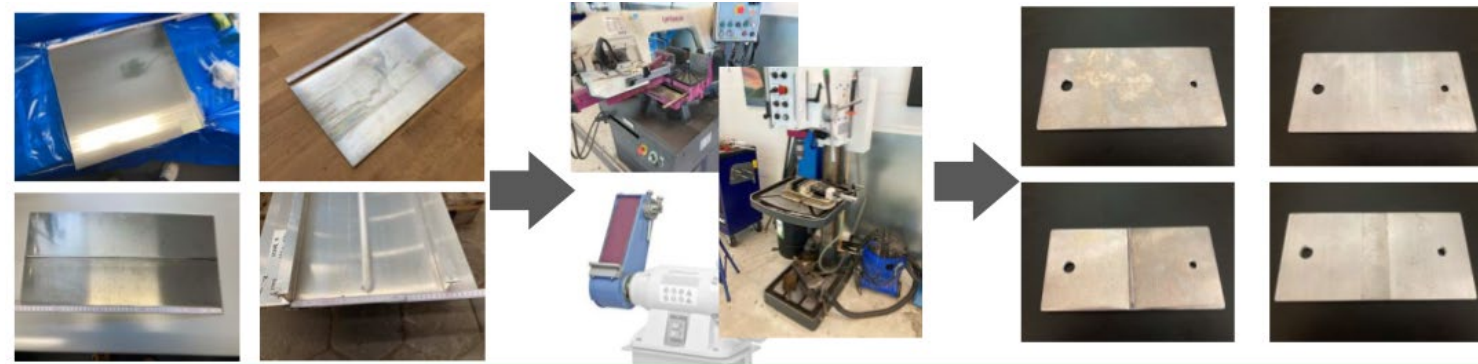
## Sample manufacturing/ preparation

- Deliver, clean, cut, mark, drill and thread all samples.
- Regarding the pre-experiments: approximately 400 samples

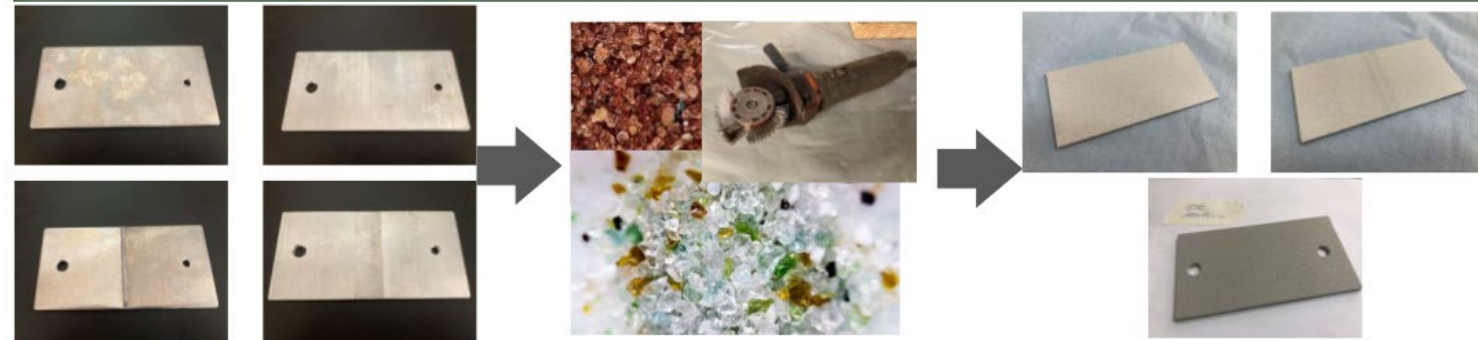
## Surface pre-treatment

- Degrease, grind, brush and blast-clean all samples.

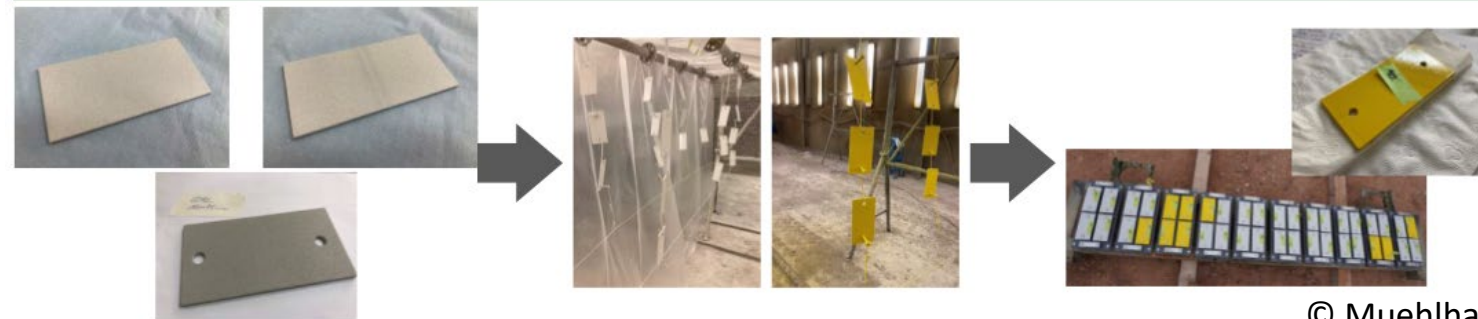
## Sample coating/handling

- Clean prepared samples with compressed air
- Mark, sort, separate and fix samples for coating application
- Coating application
- Pack samples and delivery to the project partners in Europe

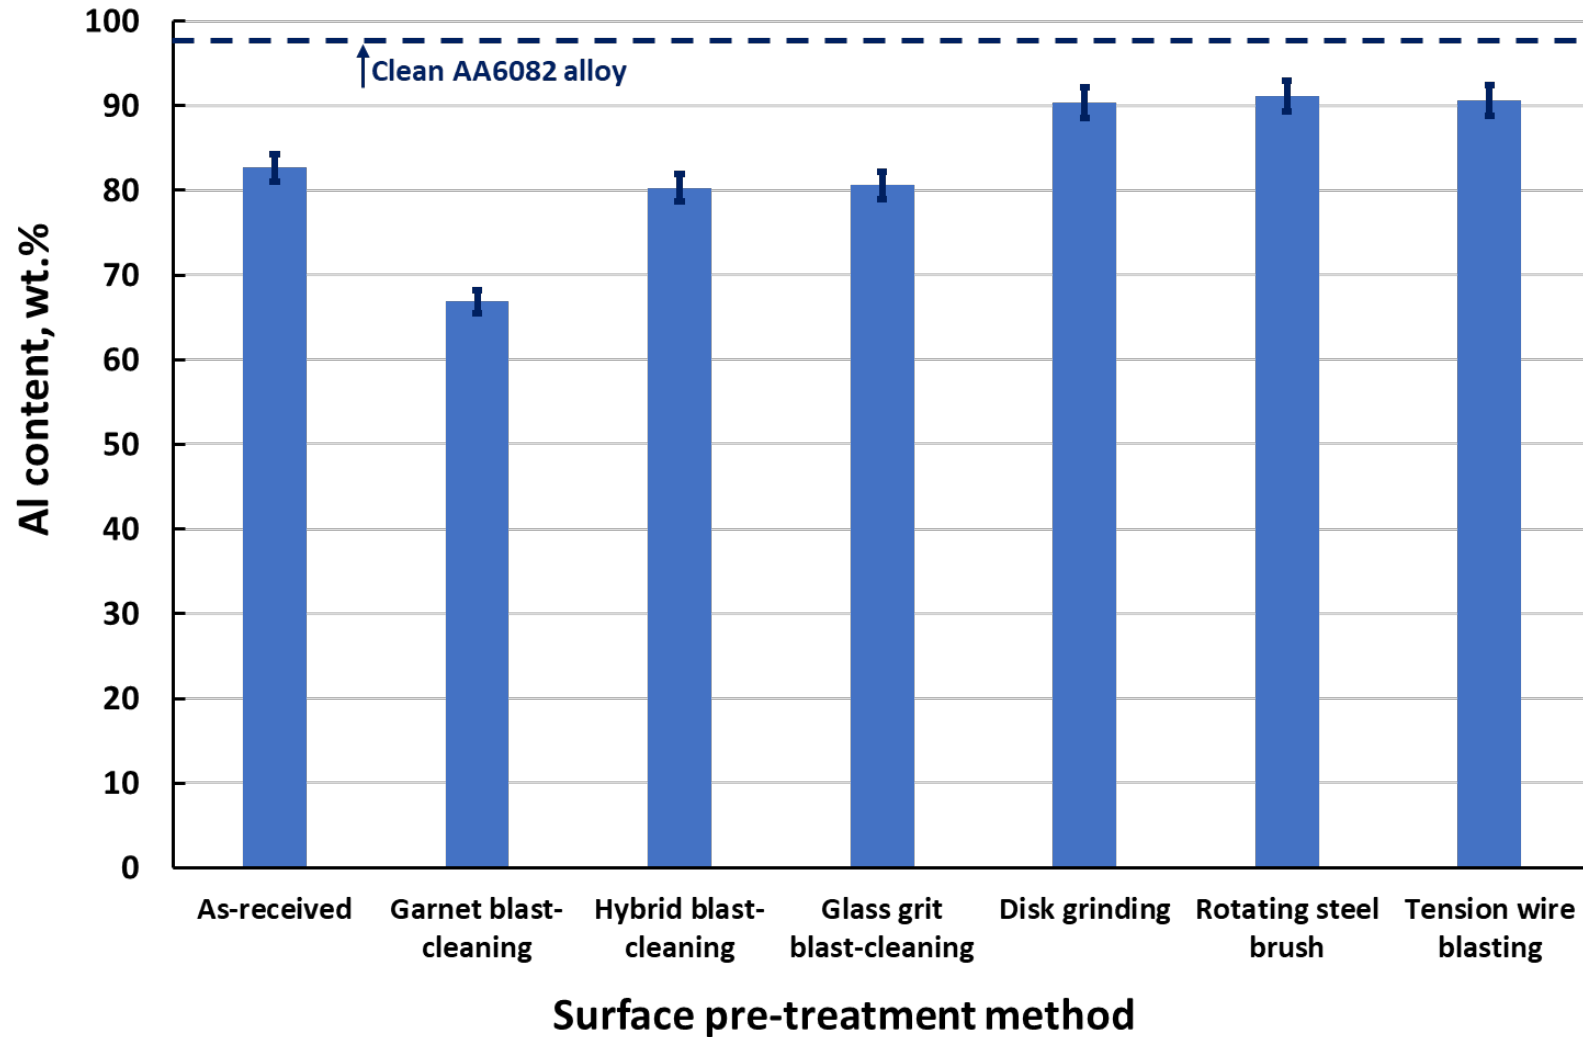
# Surface pre-treatment methods: Surface analysis with EDX

The clean alloy has an Al content of 95.2 to 98.3%

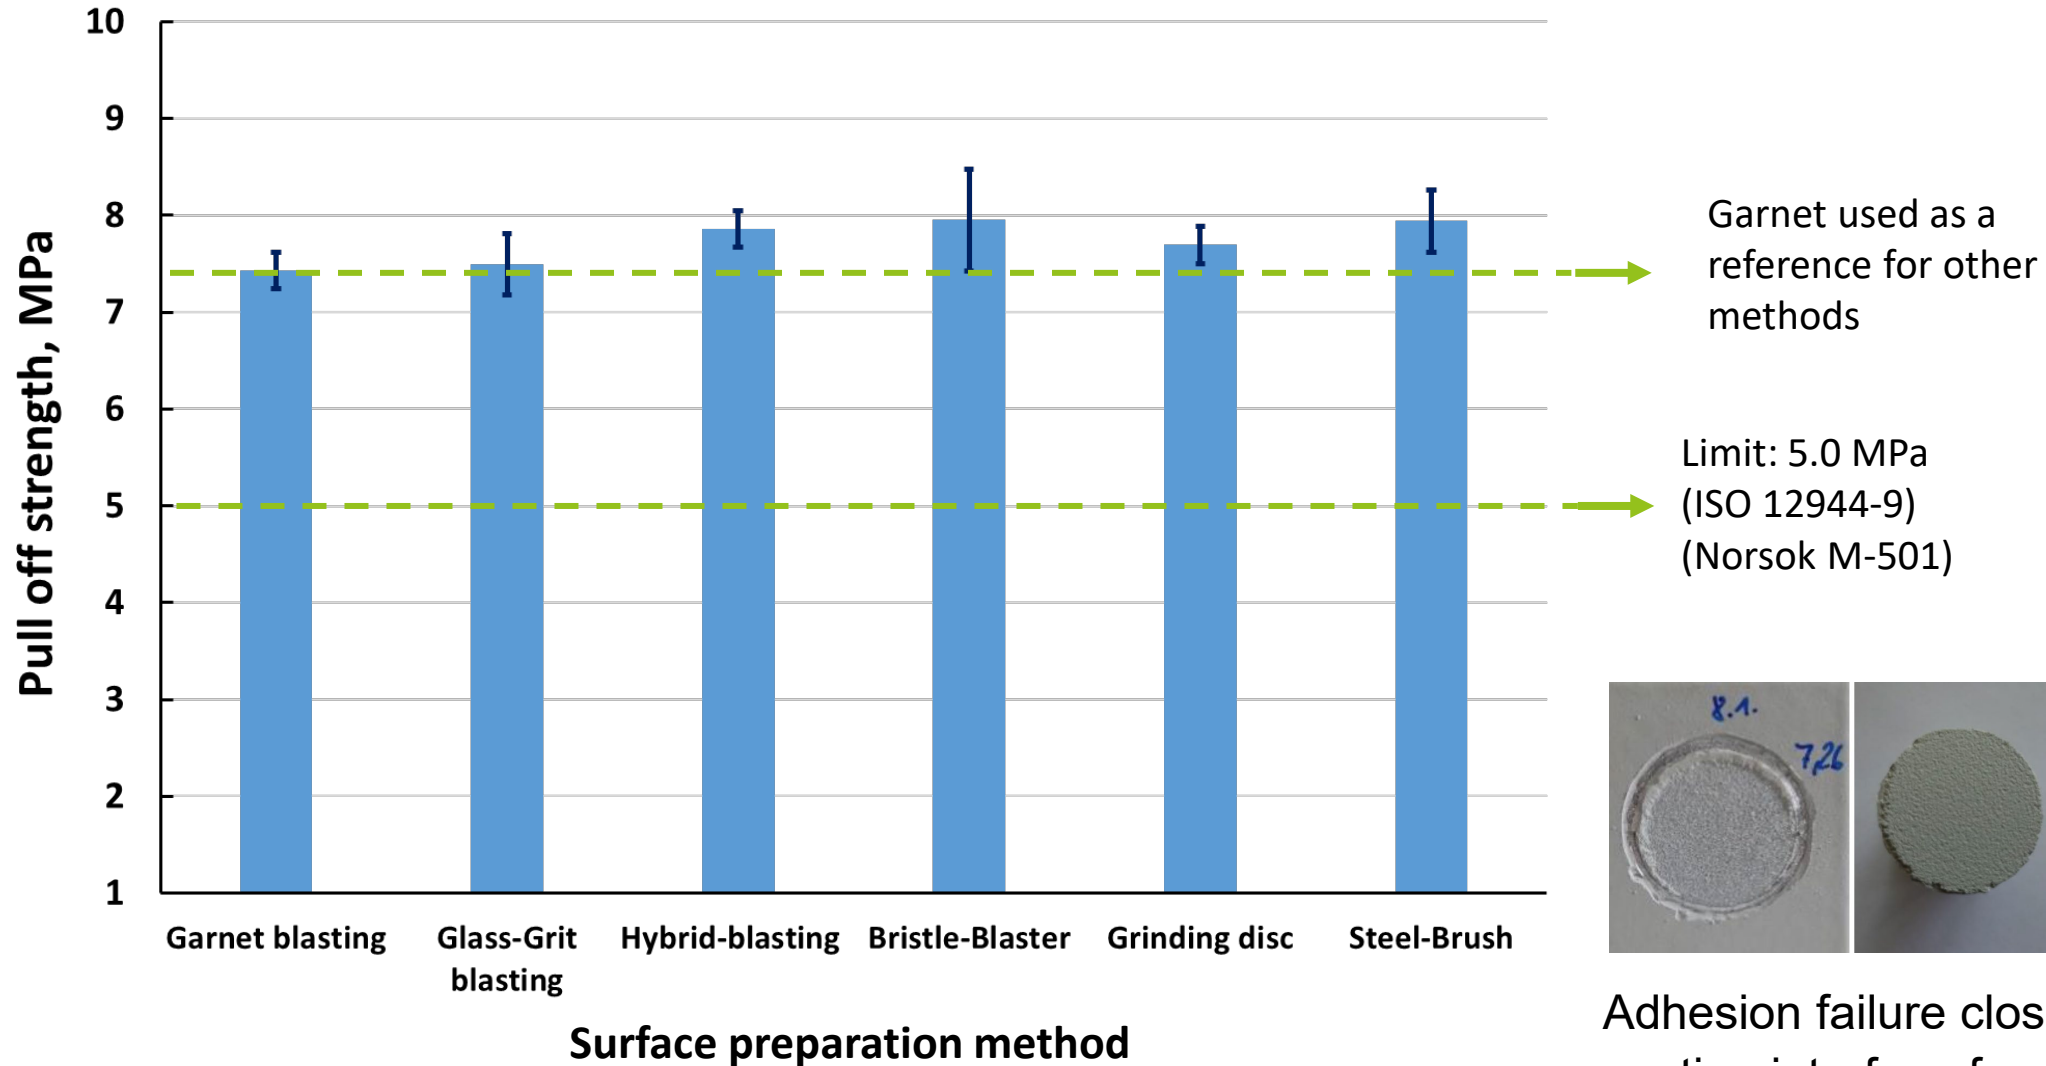
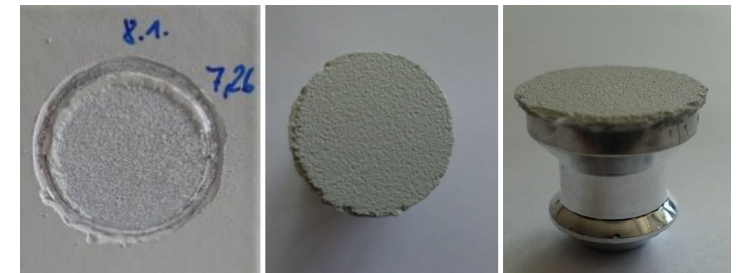
# Adhesion of not corroded coated specimens

Adhesion failure close to the metal coating interface for all specimen 14
